Lummi Nation Silver Reef Casino Mitigation Project Wetland Delineation Report

USACE Reference: 1999-4-01575

Otak, Inc.
10230 NE Points Drive, Suite 400
Kirkland, WA 98033
Otak Project No. 30908D

November 30, 2011

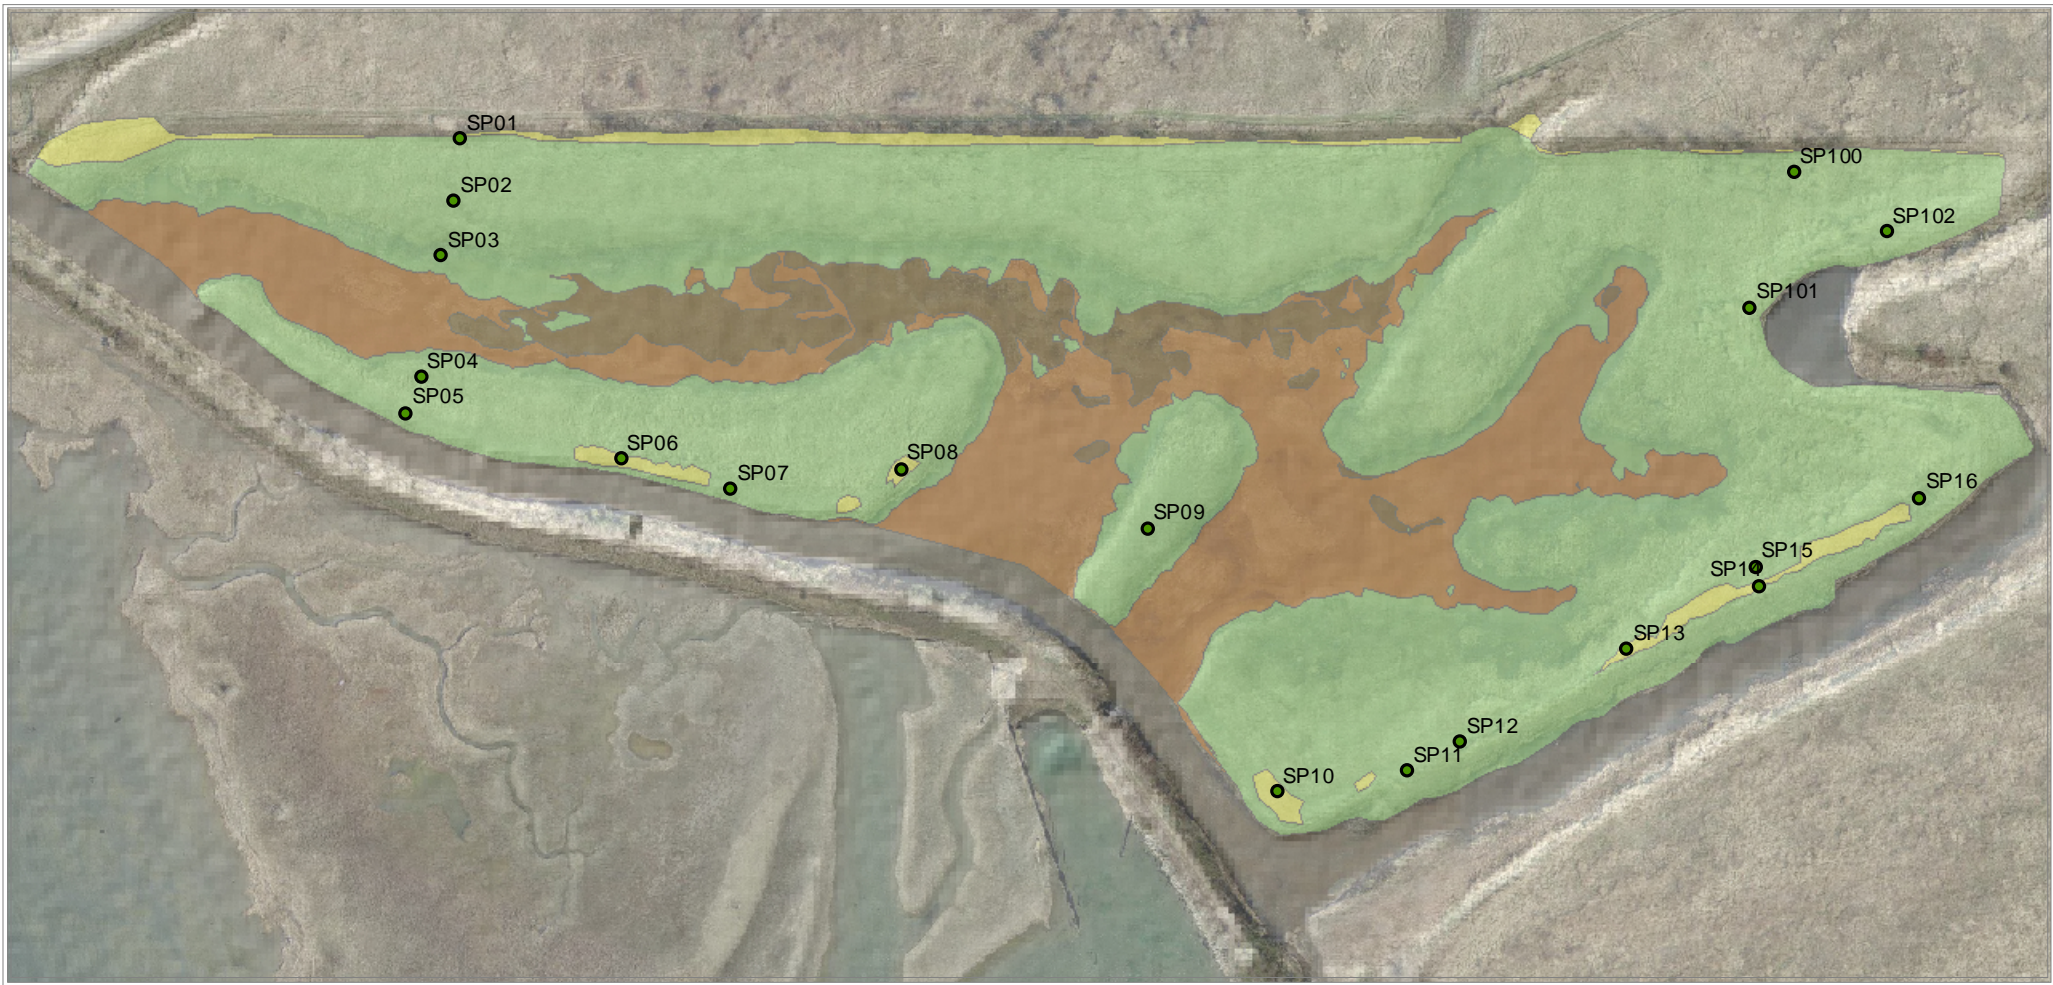
Casino Mitigation Site Delineataion and Test Pits 6/5/2011 - 8/1/2011

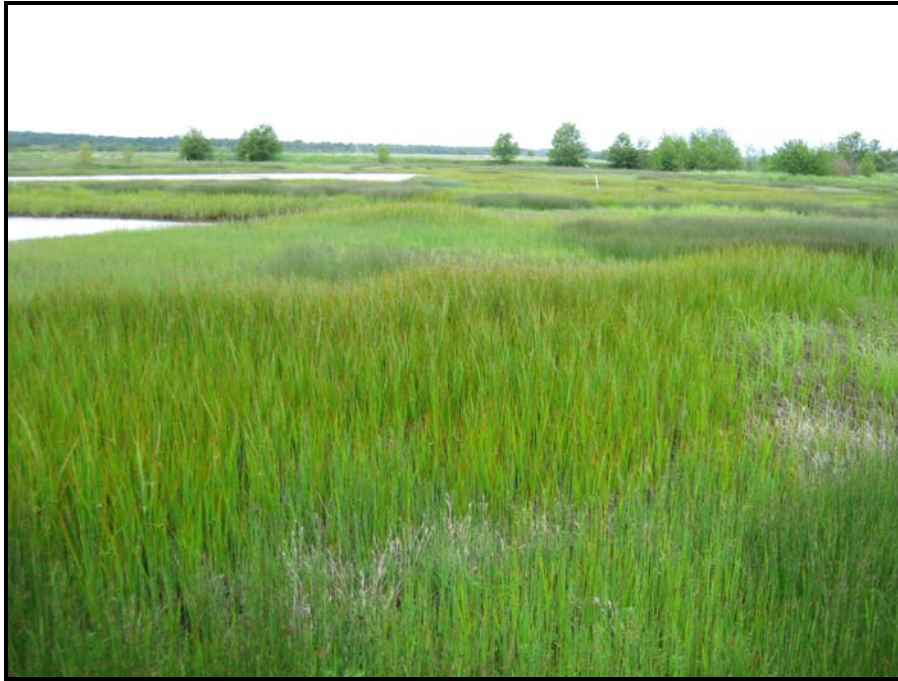
Looking west from eastern end of the mitigation area at the high saltmarsh community.

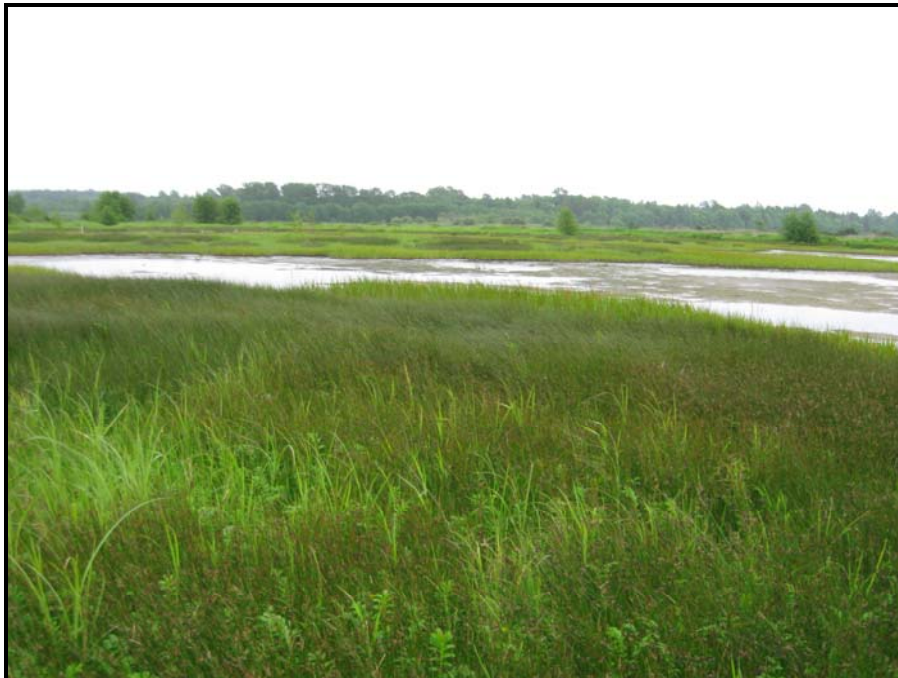
Looking east from central portion of the mitigation area – note the Baltic rush/Pacific silver weed high saltmarsh community

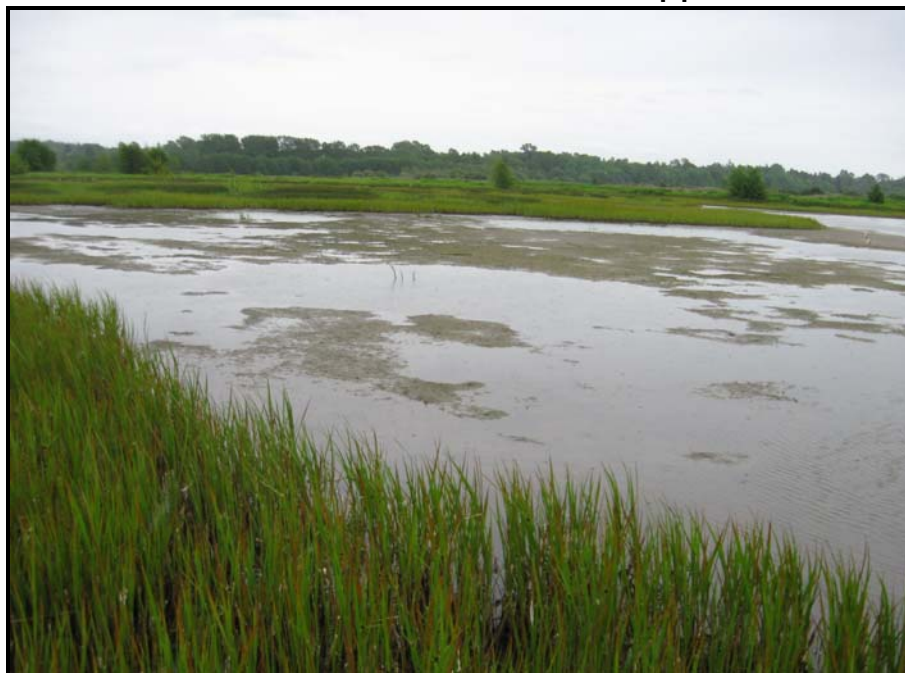
Looking east/southeast from central/eastern end of the mitigation area. Note the low saltmarsh community dominated by alkali bulrush in the foreground, and the mudflat behind.

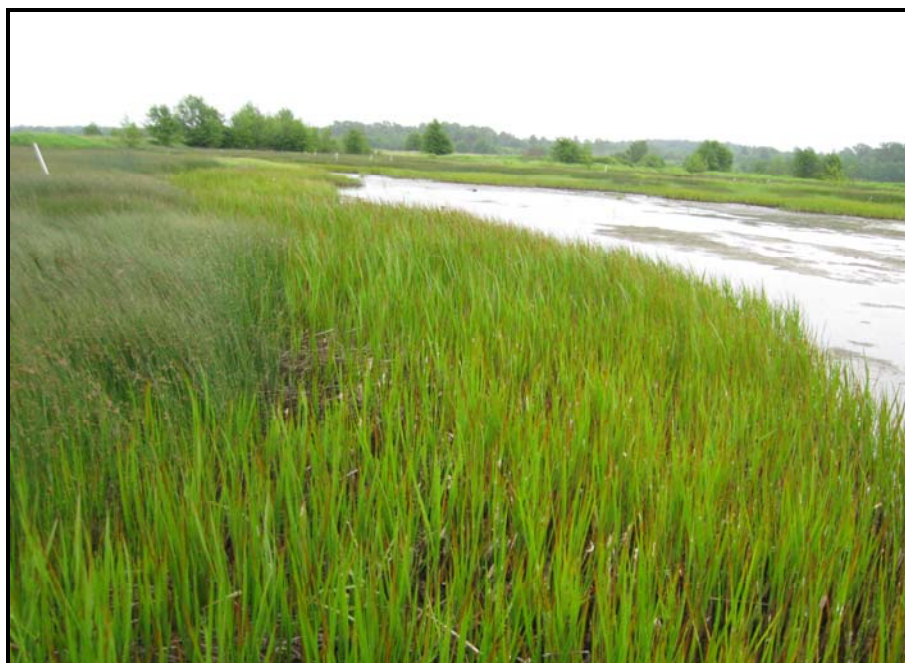
Looking east/northeast from central portion of the mitigation area. Note the transition from the low saltmarsh (lighter green alkali bulrush) to the high saltmarsh (darker green Baltic rush) community

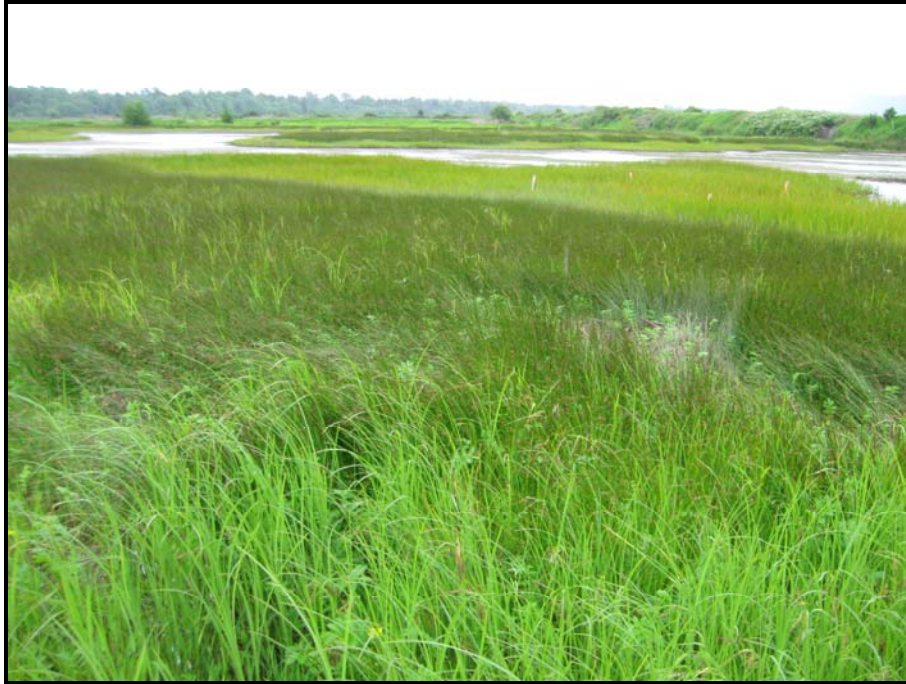
Looking east/southeast from western end of the mitigation area, with a high saltmarsh community in the foreground.

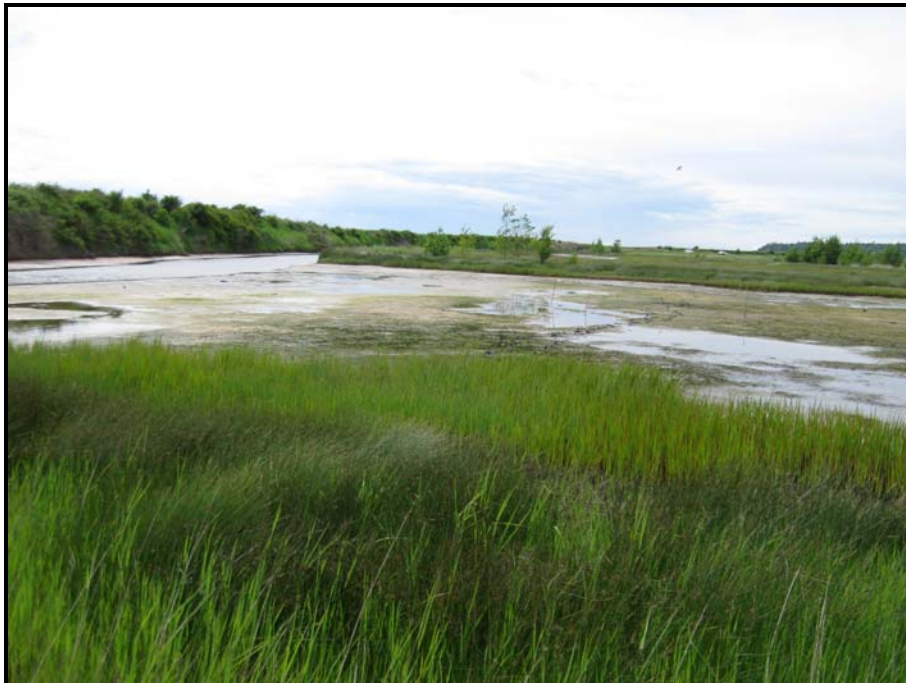
Looking west/southwest from southeast corner of the mitigation area. Note the vegetated mud flat in the center of the photo.

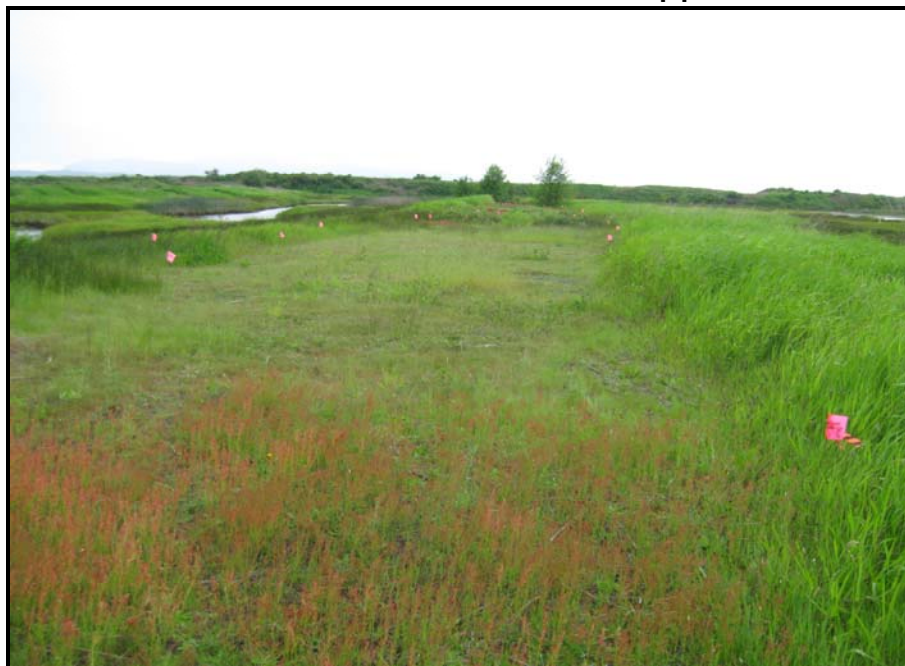
Looking south from eastern end of the mitigation area. Interior of flags (in the center of the photo) is upland (in the vicinity of SP 15), likely caused by former access/construction road.

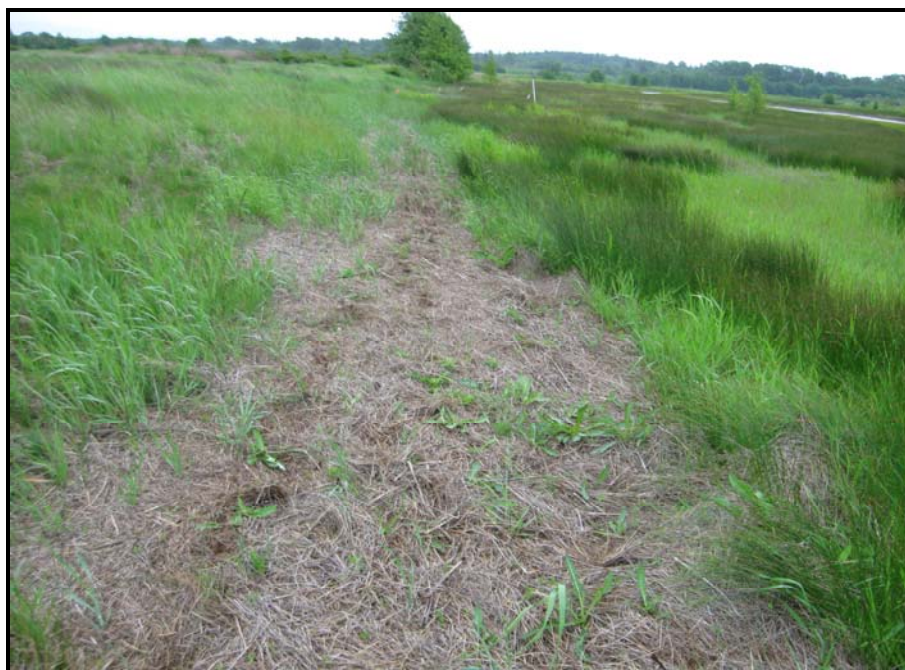
Looking east from northwest corner of the mitigation area. The central portion of photo is the wrack/debris line deposited during winter storms, near the former access road that delimits the northern project and wetland boundary .

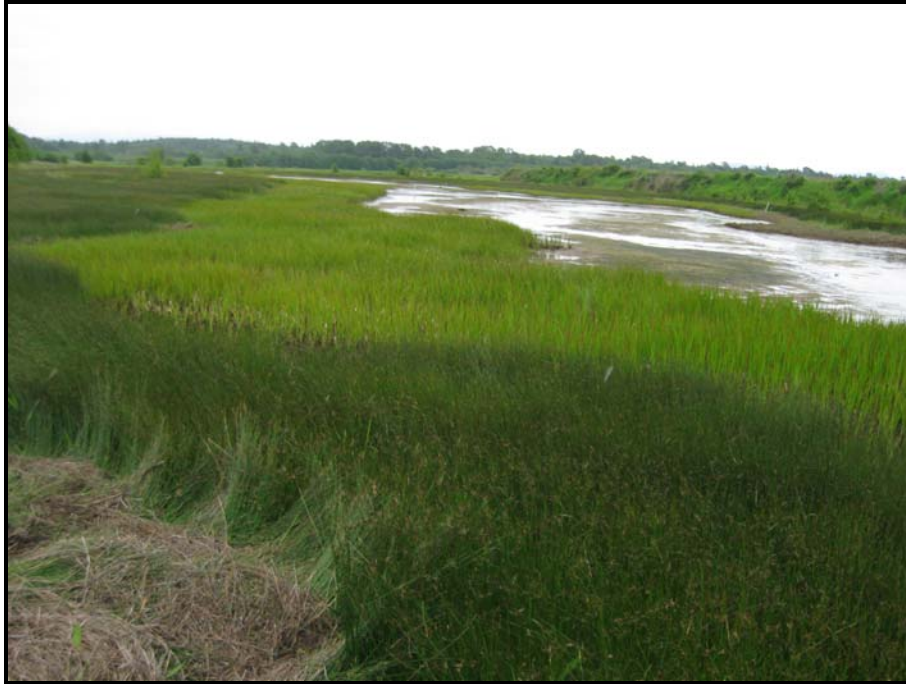
Looking east/southeast from northwest corner of the mitigation area. Note the transition from the high salt marsh (dark green Baltic rush), to the low salt marsh (lighter green alkali bulrush), to the mud flat.

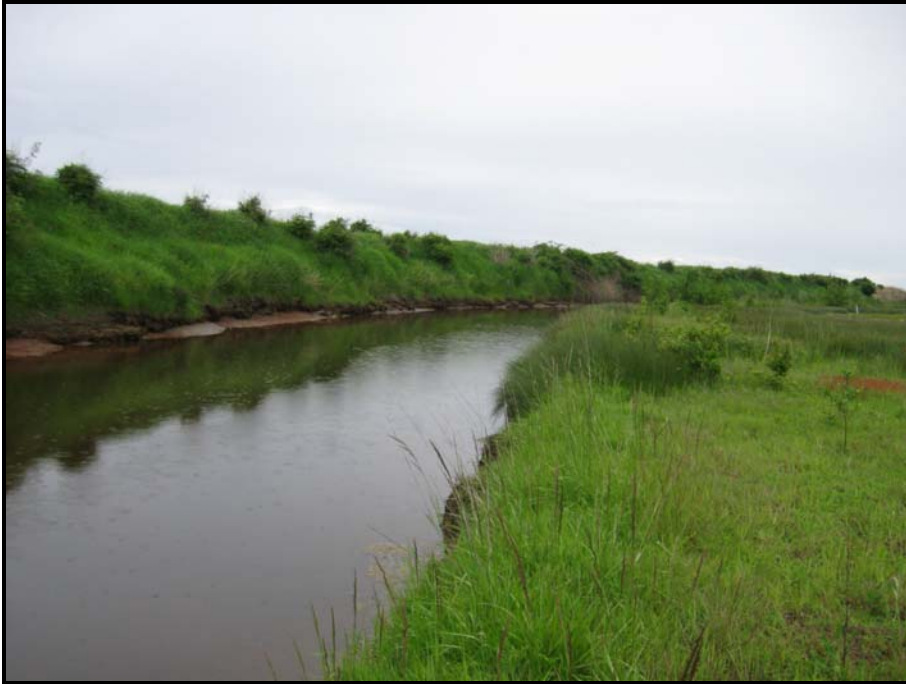
Looking west along the dike (sea wall) and slough along the southeast corner of the mitigation area - the mitigation area is in the center and right side of the photo.

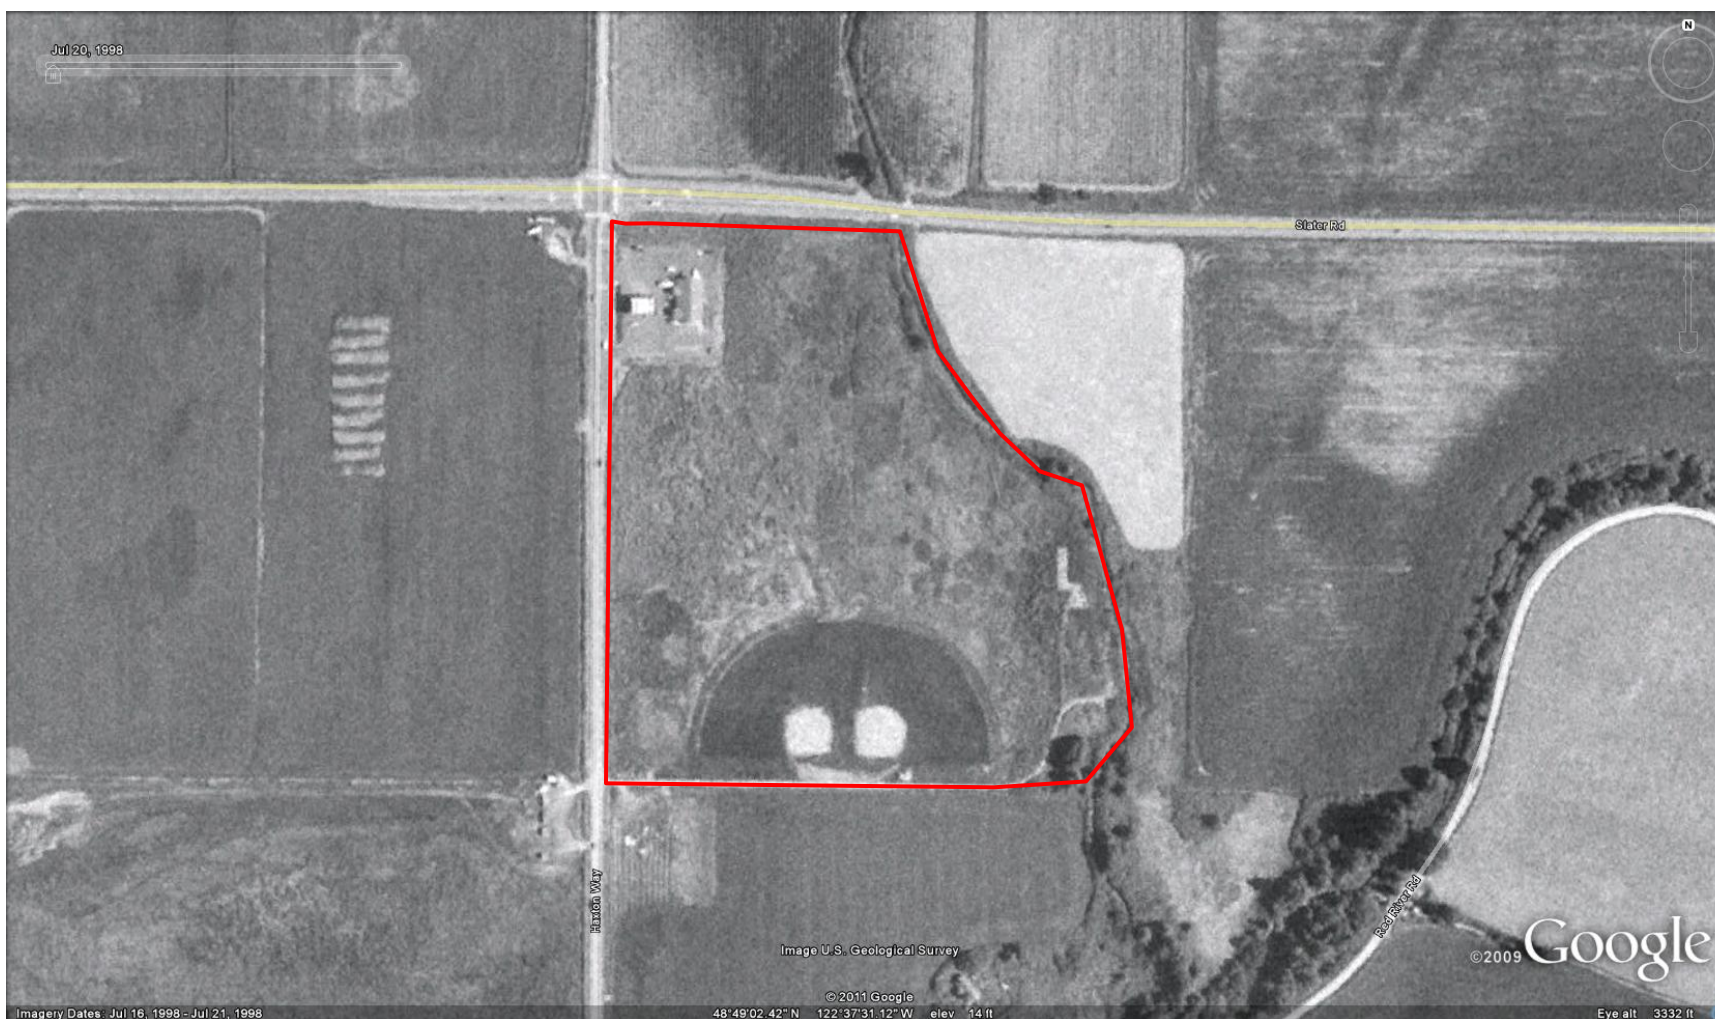
Figure 8—Silver Reef Hotel, Casino, and Spa impact site prior to construction: July 16, 1998. Note the lack of riparian vegetation along Schell Creek located along the eastern boundary of the site.

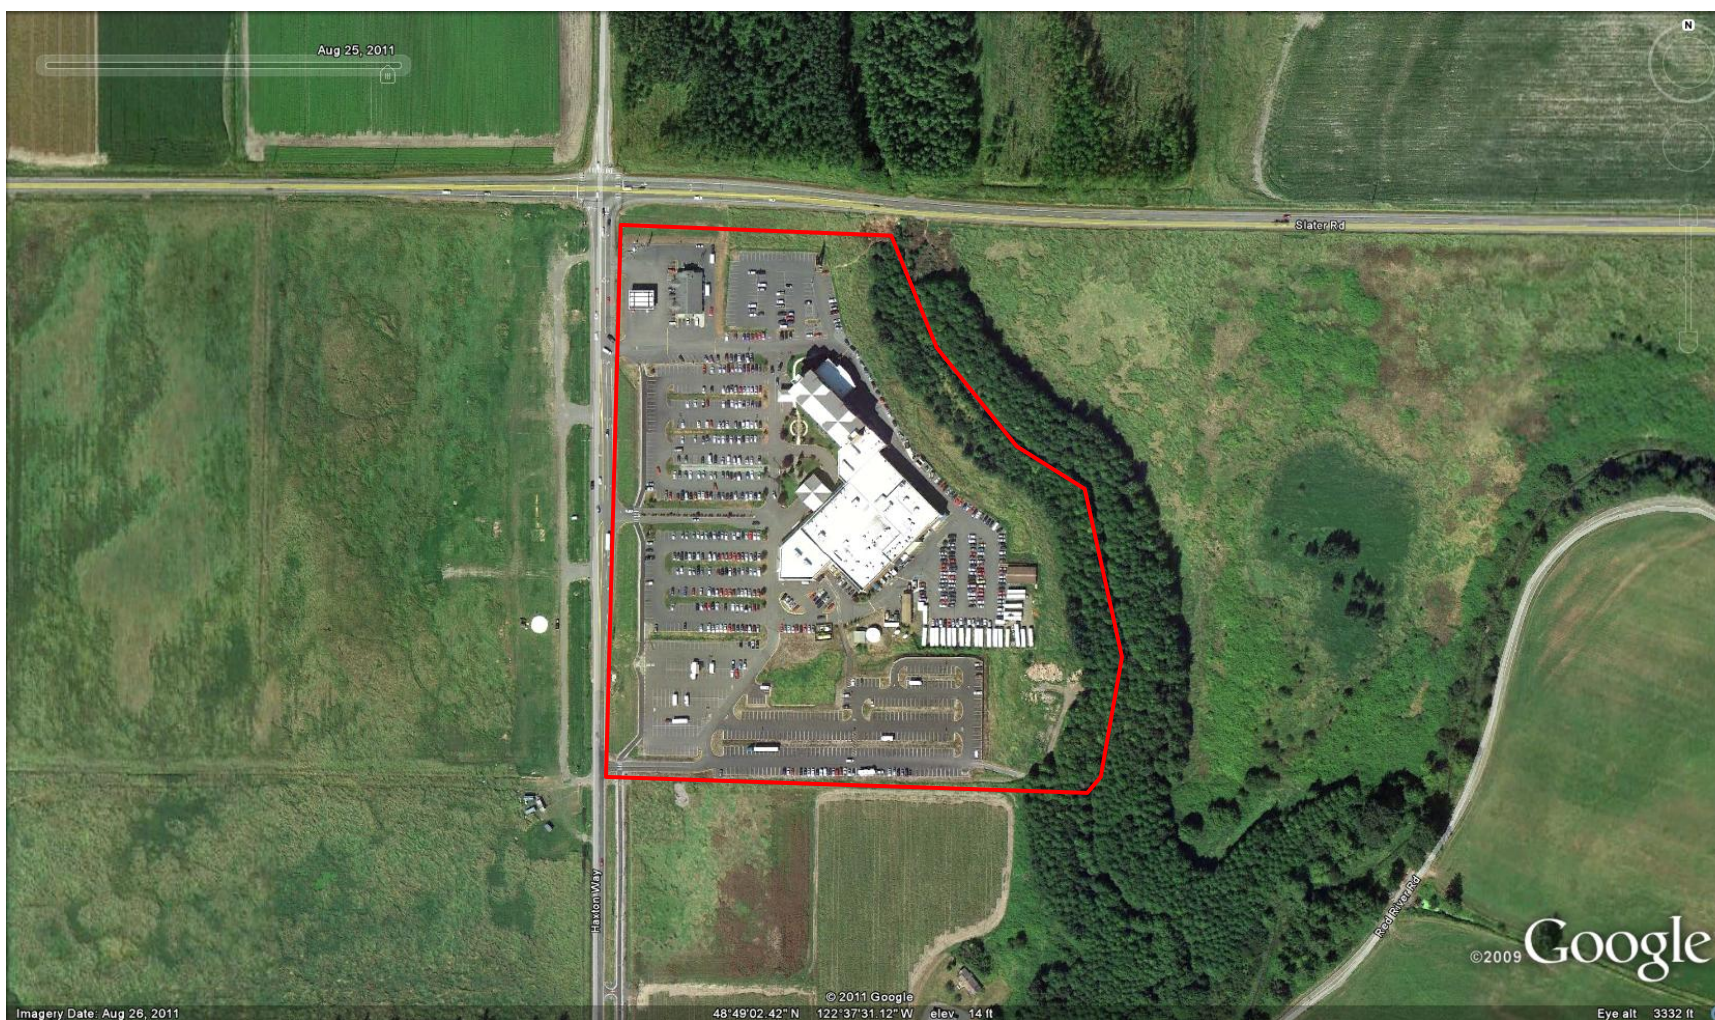
Figure 9— Silver Reef Hotel, Casino, and Spa impact site post-construction: August 26, 2011. Note the improved riparian corridor along Schell Creek located along the eastern boundary of the site.
